Marine engines with turbochargers

31-series – D16

Date: 10-2007

Breakdown prevention

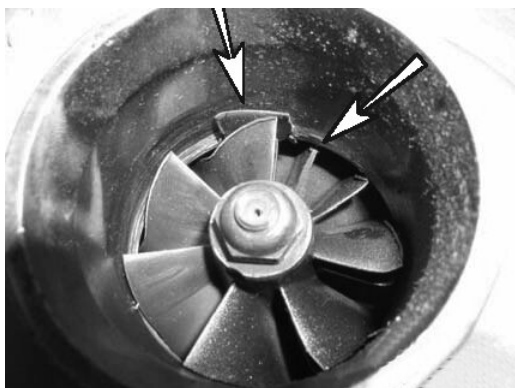
Shattered compressor blade caused by compressor wheel material fault.

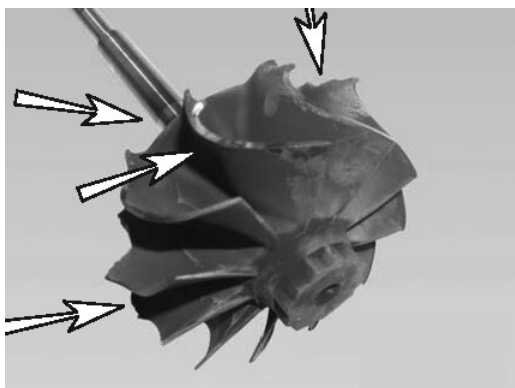
Shattered turbine blade (*) caused by accumulation of metal particles in the lubricating oil.

Pitting on the turbine shaft causes damage to the bearing and consequential damage to the turbine wheel.

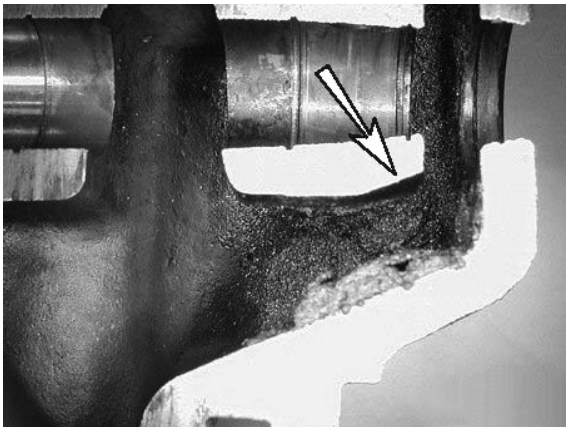
Carbonization of oil in the bearing housing (*), caused by lubricating oil starvation (lack of cooling), caused by immediate stopping of engine from full load.

Restriction/blockage in oil return line with presence of blue smoke.

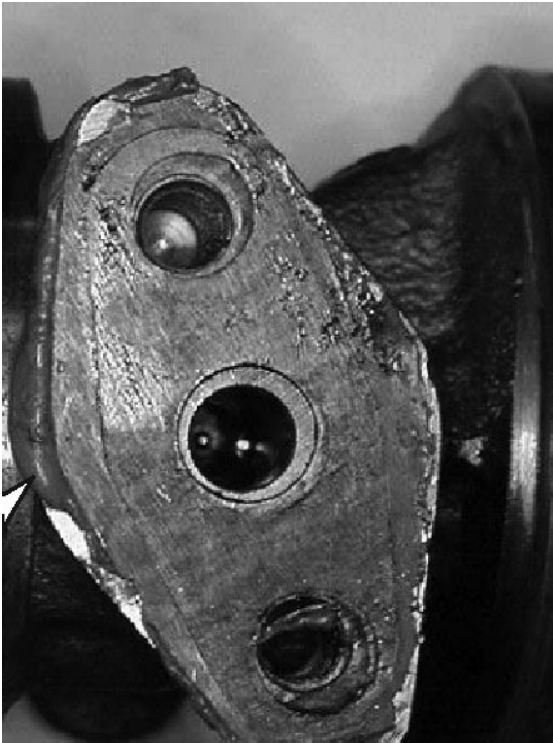
Damage to turbocharger caused by faulty assembly. (*)

Through the use of liquid sealant at the oil inlet; a quantity of the sealant squeezed into the oil inlet when the delivery pipe was fastened.

Bearing damage and total turbocharger failure after a short period.
